Memorandum

Date: February 5, 2016

*Subject: Summary of Oversight of SPME Sampler Field Inspection River Mile 10.9
January 21, 2016
Lower Passaic River Restoration Project*

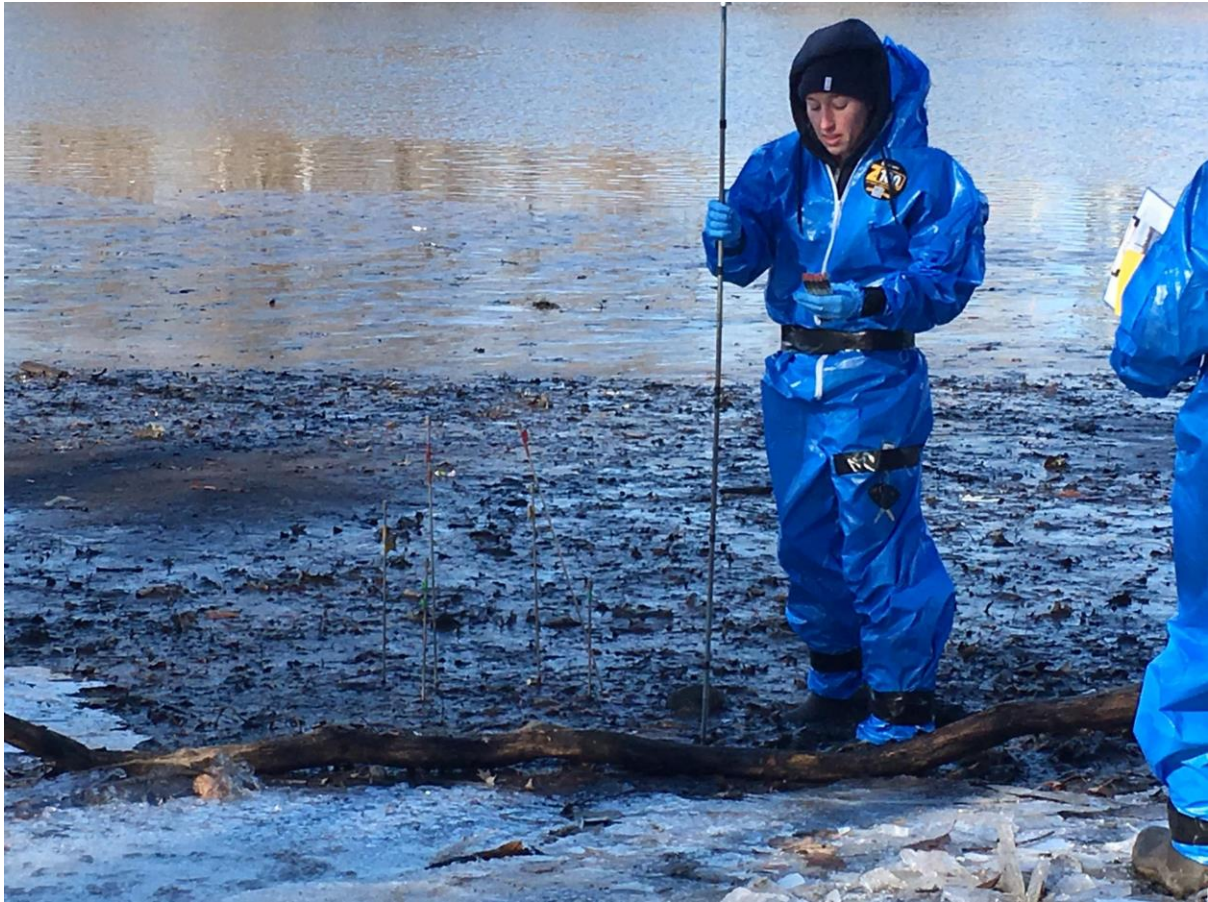
Photograph 1: Observing sediment depth on the cap at Station 607

607 - one sampler crooked and all 3 present. Crooked sampler they decide not to adjust. About 8 in sediment on cap.

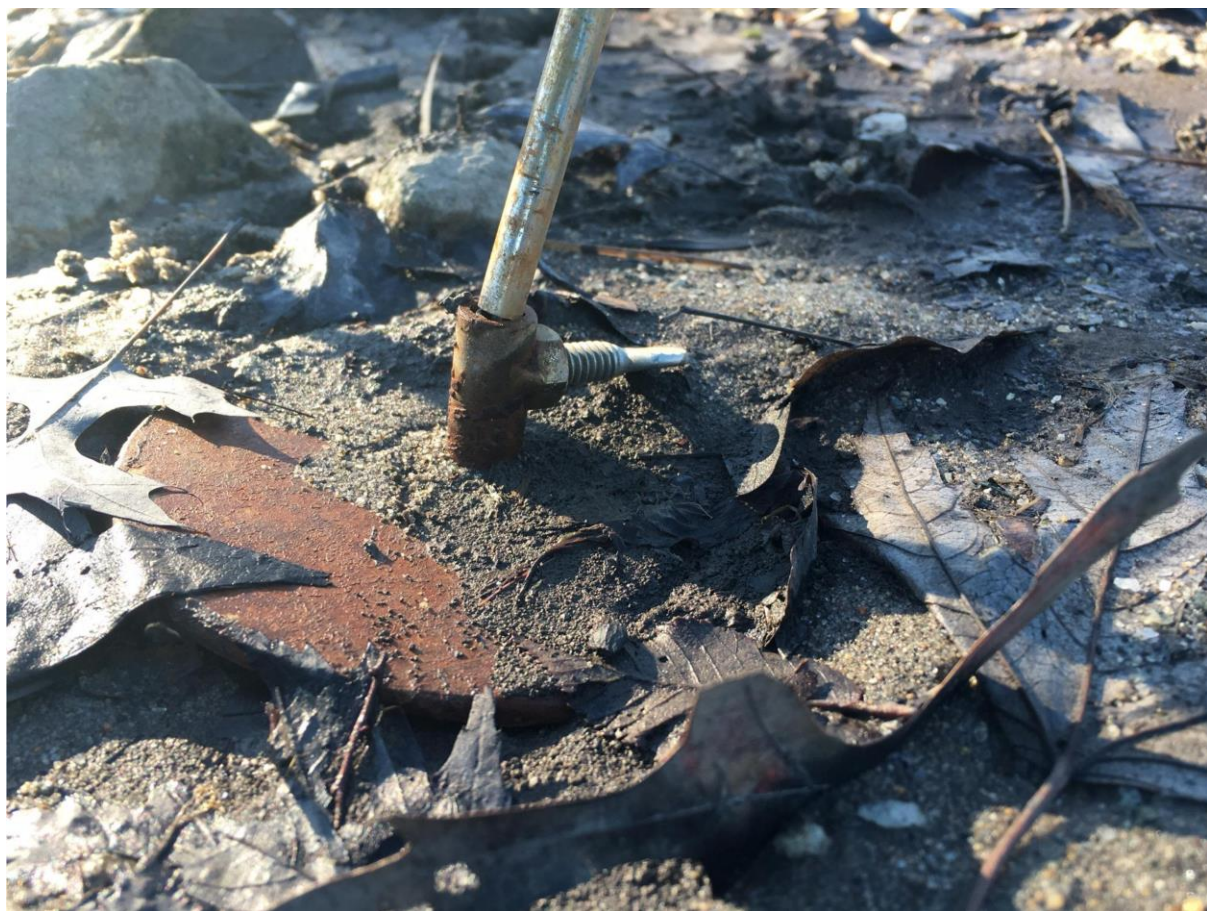
Sample station	Number of samplers observed at location	Sediment on the cap (inches)	Notes
0607 DUP	3	8	Samplers were located approximately 15 ft from water's edge (in the dry).
0608	3	2	Samplers were located approximately 1 ft from water's edge (in the dry). Sampler with red tape indicator was bent near the disk on top of the armor stone layer. When removing sampler disk to inspect the sampler the inner casing slipped down a small distance into the sediment. This sampler should be inspected for further damage following retrieval.

Photograph 2: Bent shallow sampler at location 0608

1256 Shallow sampler (red) at 608 appears to be cracked above the disk. AECOM decides to remove the disk and try and tape the crack.

1320 After further investigation the crack just seems to be the opening at the top of

Sampler protective casing above the disk when they tried to remove the disk it slipped the sampler slightly deeper in the sediment. They conclude the sampler is not cracked but just slightly bent (picture)
